## The "Crystal Gayle effect" or How a Song can Shut off a Radio Broadcast Transmission

There have been several Eimac tubes that went to market only to discover later they had latent defects in their design. The 3CX3000A7 was one of them.

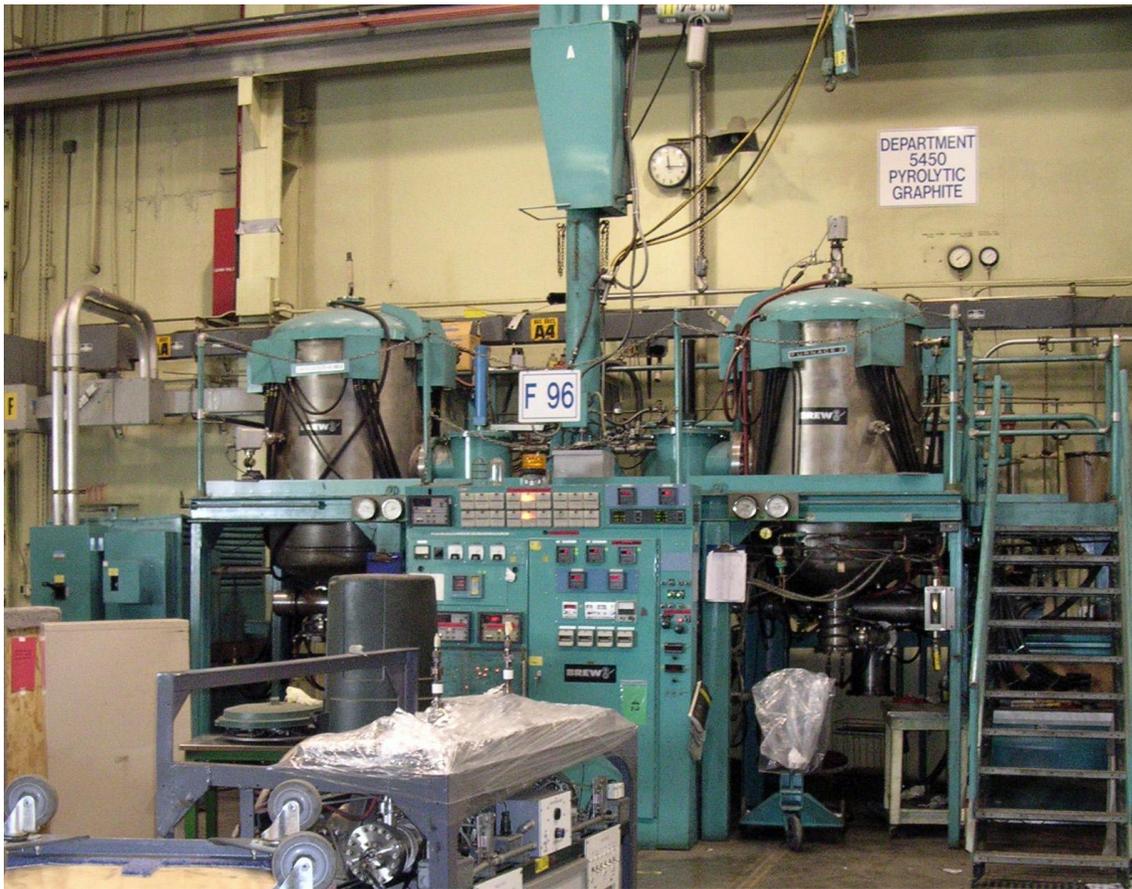
In 2006 CPI sold the property where the Eimac San Carlos plant had been operating since it was built in 1958 and the PG furnaces were moved to CPI's Mountain View machine shop (now closed) and stored outside in the rear parking lot. The largest of Eimac's PG furnaces stood approx. 20 feet high (pic below). These were never incorporated into the Palo Alto facility where Eimac was integrated into the ex-Varian Microwave Power Products facility and after several of sitting outside exposed to the

Pyrolytic graphite furnaces being disassembled for shipment (San Carlos, 2006).
